DEPARTMENT OF TRANSPORTATION

Quality Assurance and Source Inspection

Contract #: 04-0120F4Cty: SF/ALA Rte: 80 PM: 13.2/13.9File #: 1.28**WELDING INSPECTION REPORT****Resident Engineer:** Pursell, Gary**Address:** 333 Burma Road**City:** Oakland, CA 94607**Report No:** WIR-013488**Date Inspected:** 29-Apr-2010**Project Name:** SAS Superstructure**OSM Arrival Time:** 1100**Prime Contractor:** American Bridge/Fluor Enterprises, a JV**OSM Departure Time:** 1930**Contractor:** American Bridge/Fluor Enterprises, a JV**Location:** Job Site**CWI Name:** See Below**CWI Present:** Yes No**Inspected CWI report:** Yes No N/A**Rod Oven in Use:** Yes No N/A**Electrode to specification:** Yes No N/A**Weld Procedures Followed:** Yes No N/A**Qualified Welders:** Yes No N/A**Verified Joint Fit-up:** Yes No N/A**Approved Drawings:** Yes No N/A**Approved WPS:** Yes No N/A**Delayed / Cancelled:** Yes No N/A**Bridge No:** 34-0006**Component:** Orthotropic Box Girders**Summary of Items Observed:**

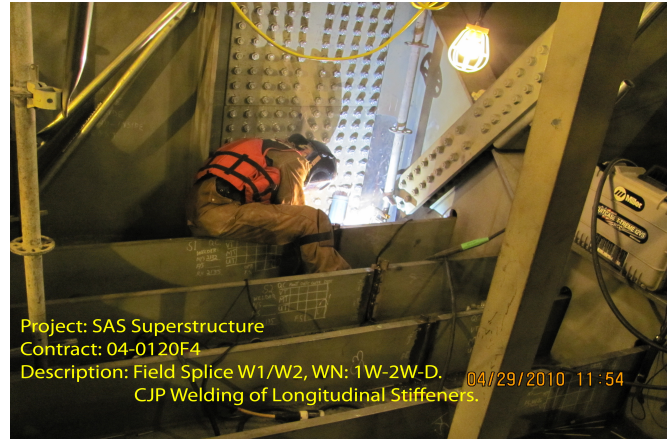
The QAI also observed the continued Shielded Metal Arc Welding (SMAW) of the bottom plate longitudinal stiffener field splices identified as Weld Number (WN): 1W-W2-D-S5. The welding was performed by the welding personnel James Zhen ID-6001 utilizing the Welding Procedure Specification (WPS)

splices identified as Weld Number (WN): 1W-W2-D-S11. The welding was performed by the welding personnel Chun Fai Tsui ID-3426 utilizing the Welding Procedure Specification (WPS) ABF-WPS-D15-1010 Rev. 0 for the CJP welding of the double-v-groove joint identified as per the AWS joint designation B-U3b. The WPS was also used by the QC Inspector as a reference to monitor and verify the Direct Current Electrode Positive (DCEP) welding parameters. Later in the shift the QAI observed the QC inspector monitoring the welding and verifying the welding parameters and were noted as 117 amps. The QC inspector also monitored the surface temperatures during the field welding and the following was observed and noted by the QAI: the minimum preheat temperature of 20 degrees Celsius and the maximum interpass temperature of 230 degrees Celsius.

At approximately 1515 the QAI observed a linear indication was noted by the QC inspector Bonifacio Daquinag utilizing the Magnetic Particle Testing (MPT). The indication was discovered when performing the testing of the excavation of a UT reject on the edge plate "B" field splice. The QAI notified QC Supervisor Leonard Cross of this issue and at the conclusion of the review Mr. Cross contacted Welding Quality Control Manager (WQCM) Jim Bowers. Mr. Bowers instructed Mr. Cross to proceed with the excavation at this time. The welder, Jordan Hazelaar performed the excavation and QC inspector Mr. Daquinag performed the visual inspection and testing. The excavation and MPT was completed during this shift and no rejectable indications were noted by the QC inspector. The repair welding is pending the submittal and approval of the Welding Repair Request.
